Glass container defects Causes and remedies

It is essential that the machine operator be able to identify defects quickly and accurately, and to know how to remedy them. In this handbook all the major defects have been listed with an accurate description and sketch indicating the appearance of the defect and the position in the container where it is most commonly found.

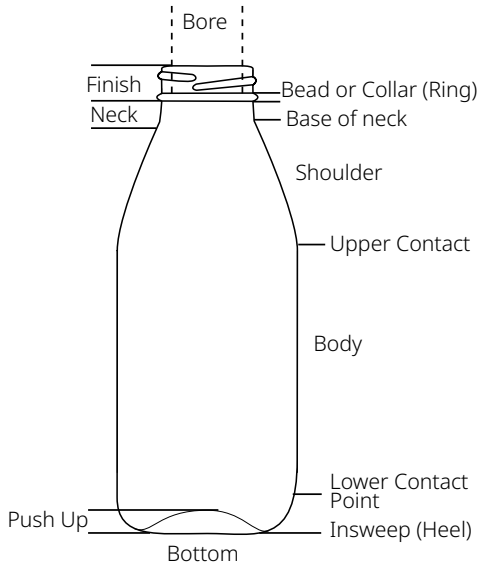
The various parts of a container

Finish This is the top of the container above the neck ring parting line.

Bottom plate parting line Where the blow mold and bottom plate join there is a seam.

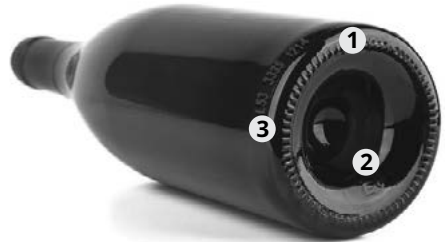
Punt marks are used by glass manufacturers to identify their containers. You can learn about containers by reading these punt marks.

- 1 Cavity Identification** The bumps on the heel and/or rings on the bottom enable inspection equipment to read the bottle information
- 2 Manufacturer's mark**
- 3 Additional information** may include plant identification, year manufactured, mold number, container capacity and fill level
